SONY KV27v42 RGB upgrade.
04/Sep/2020

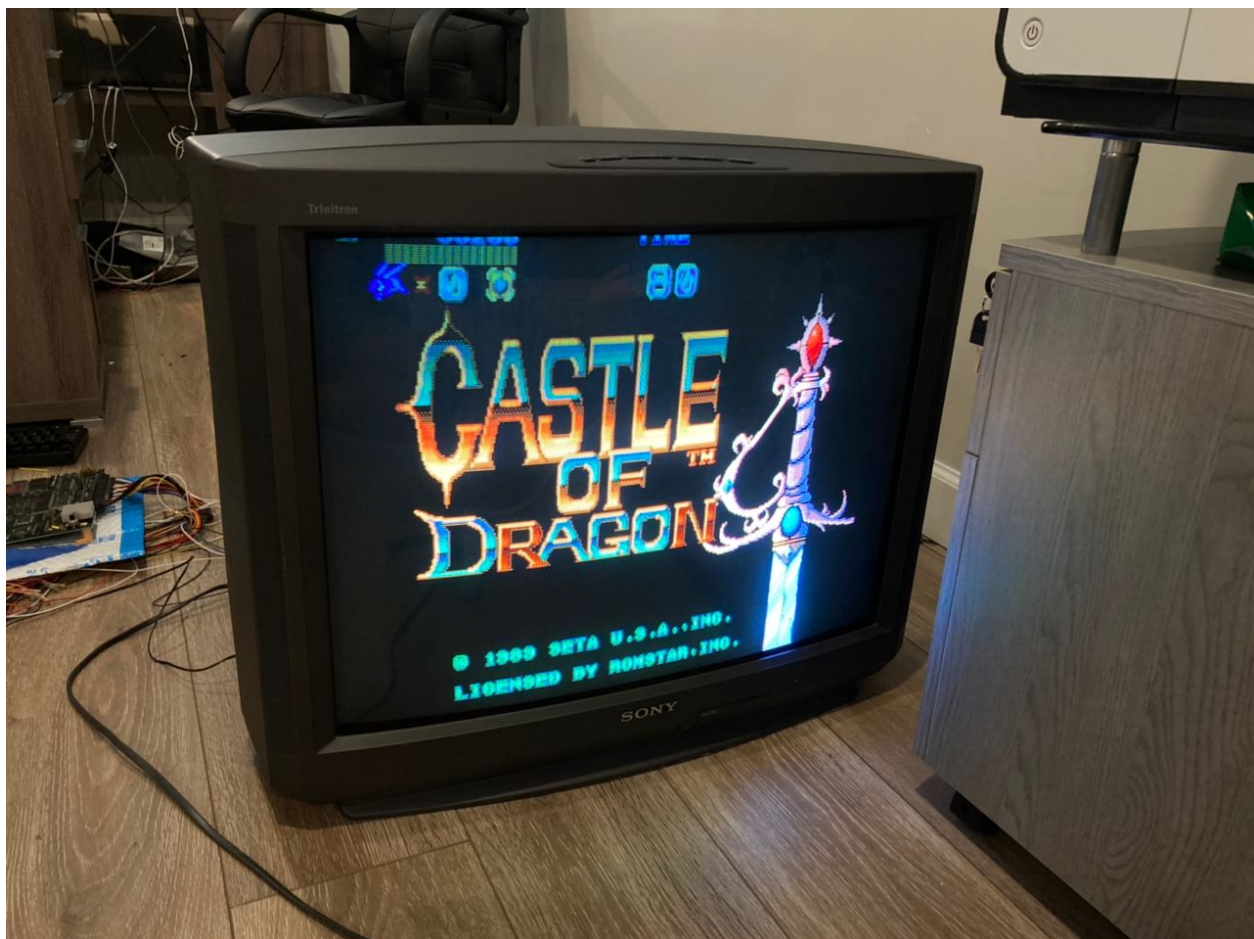
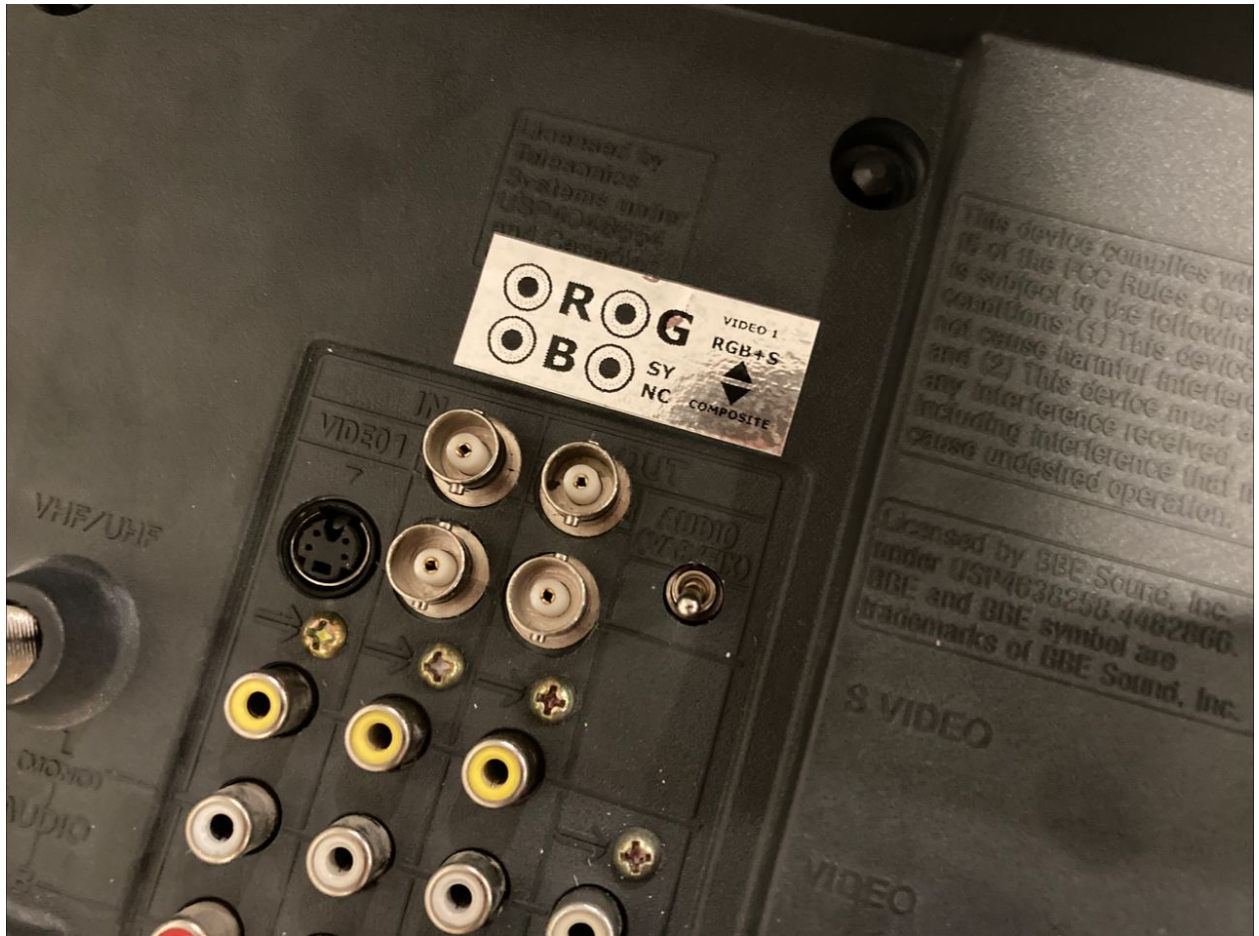
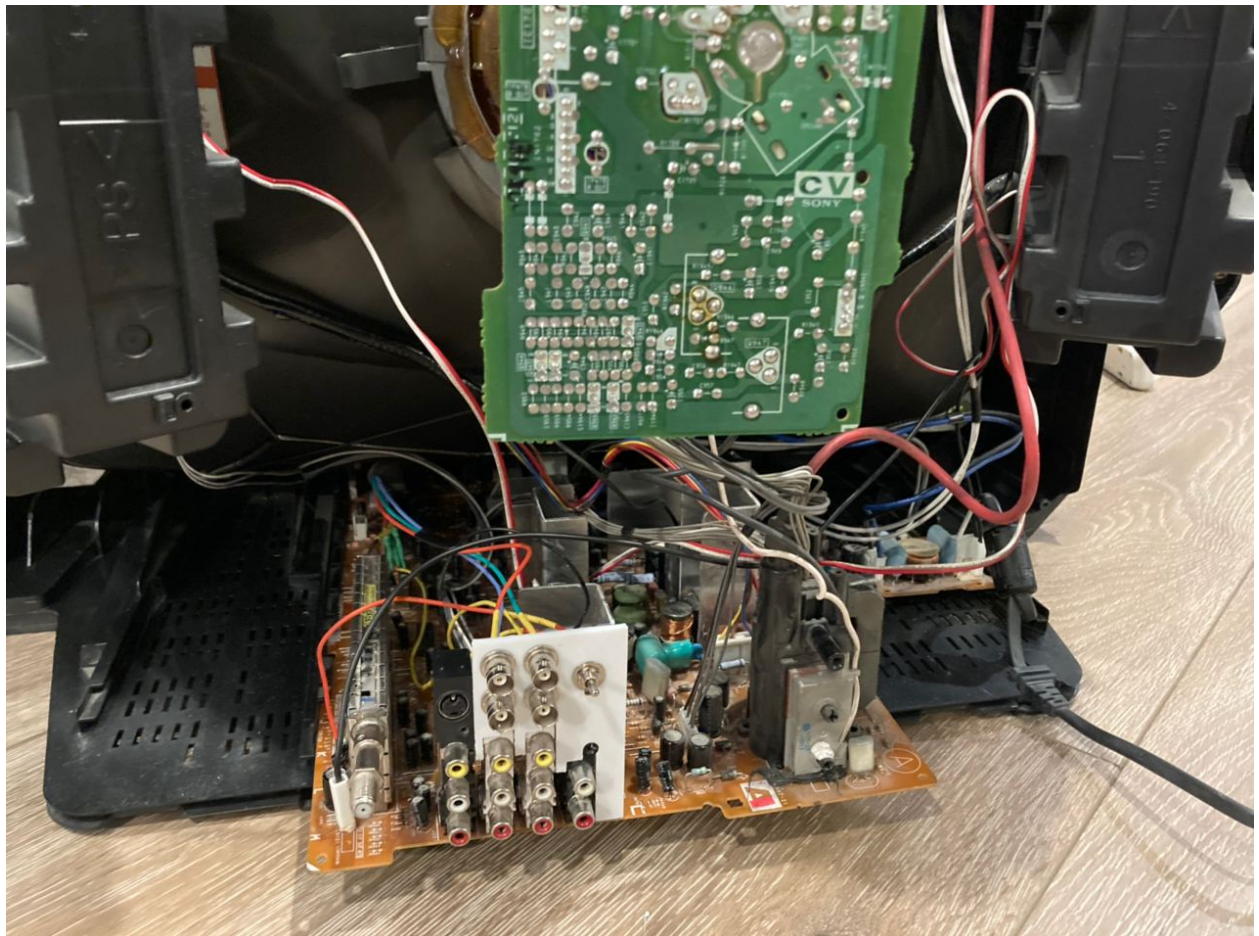
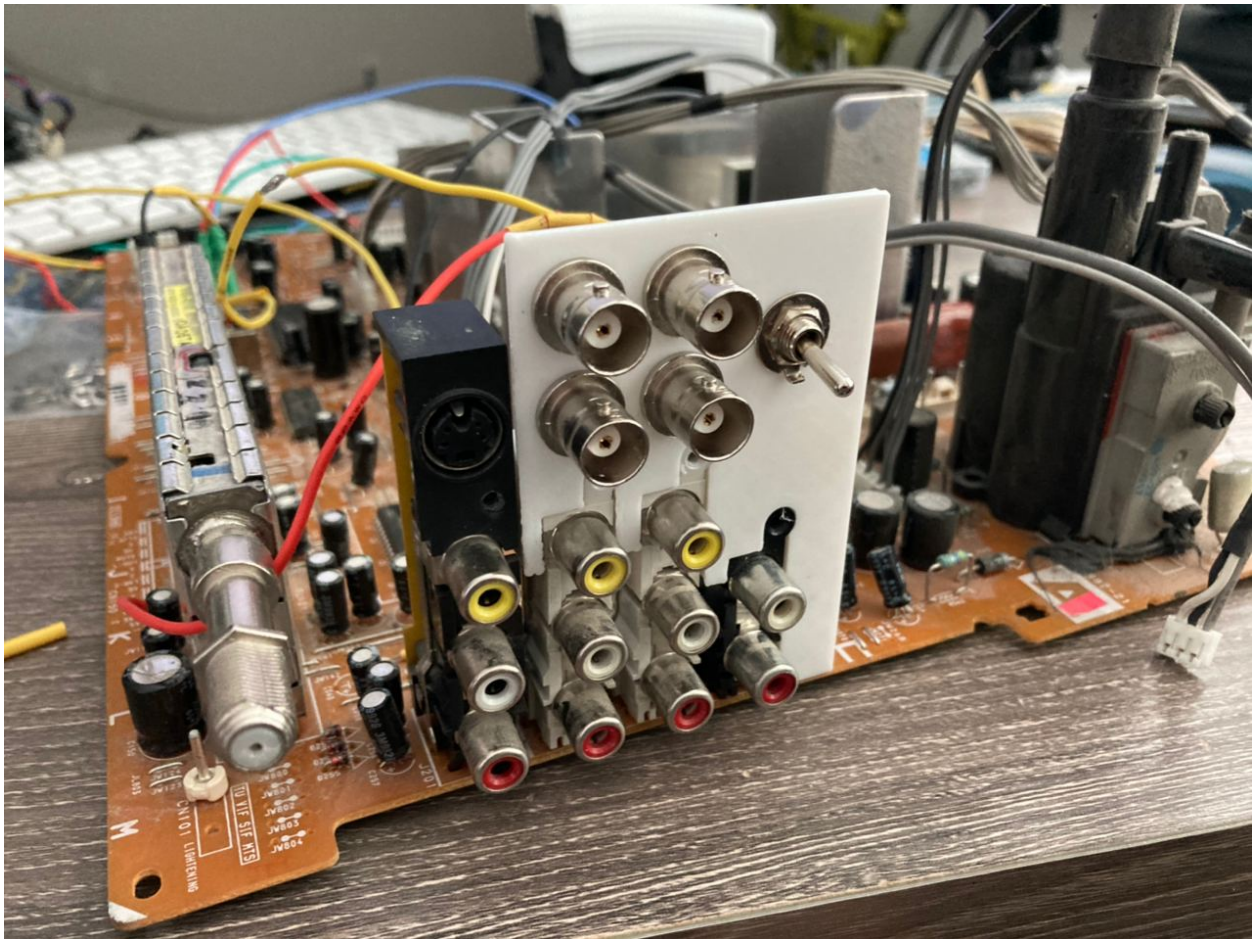
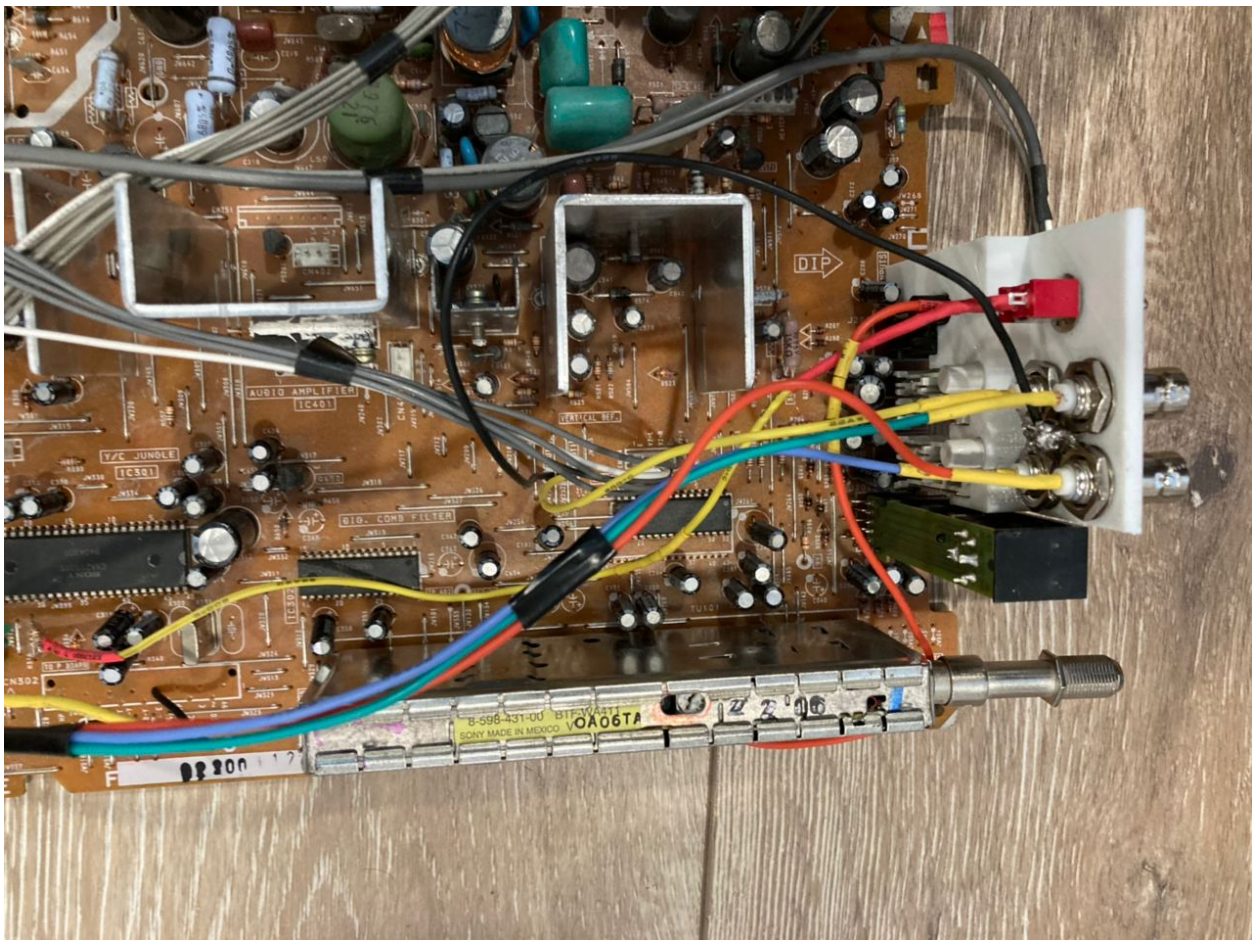
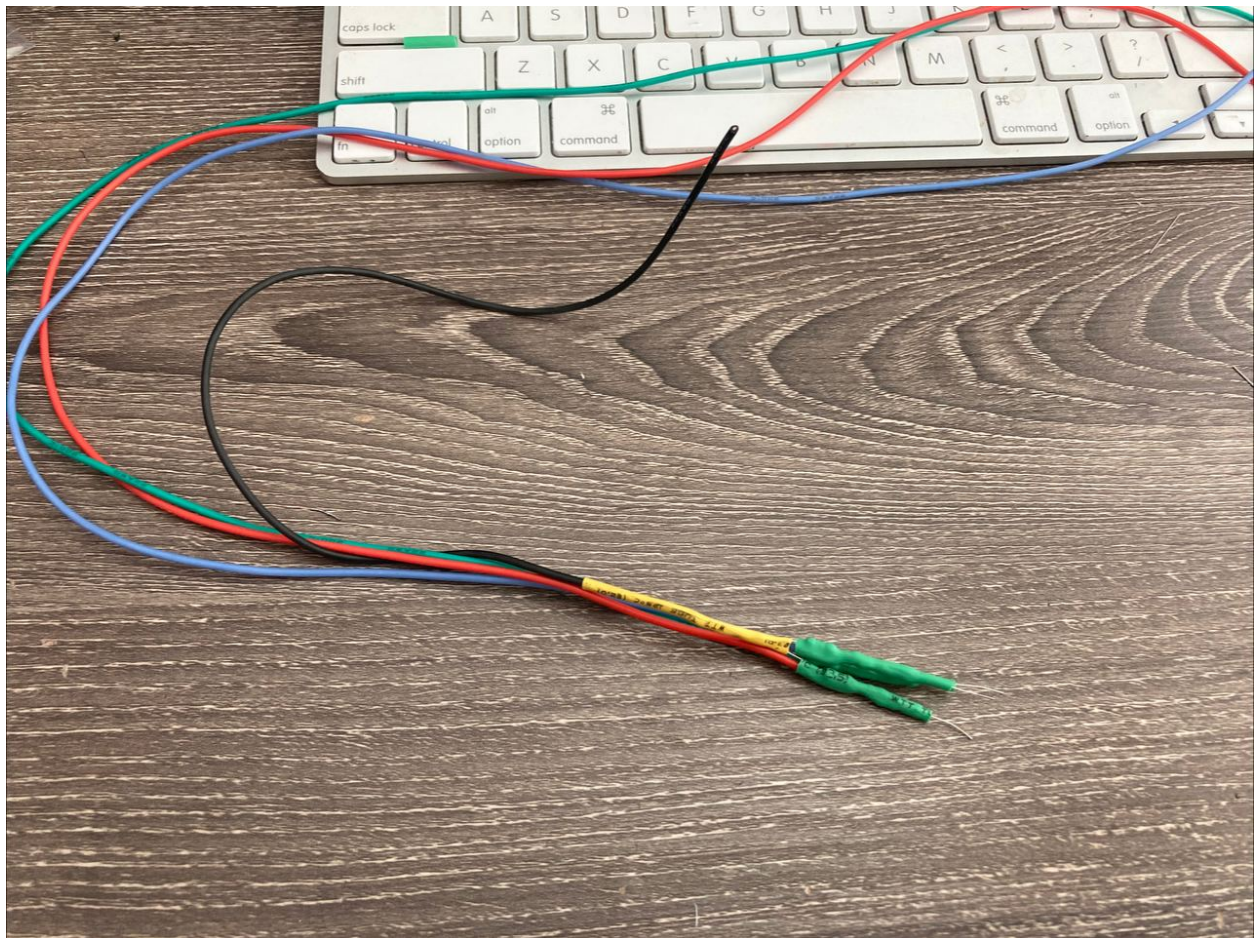
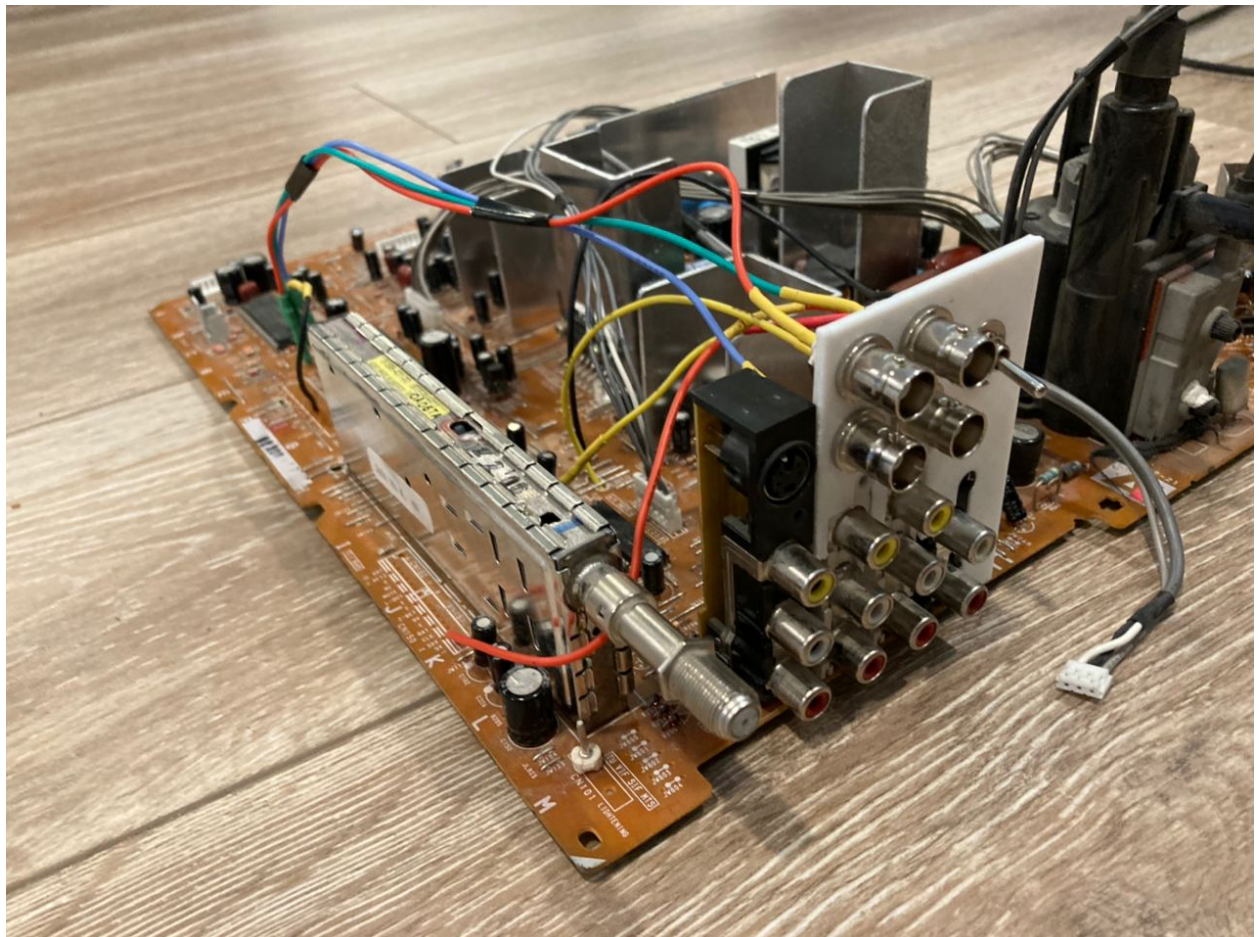
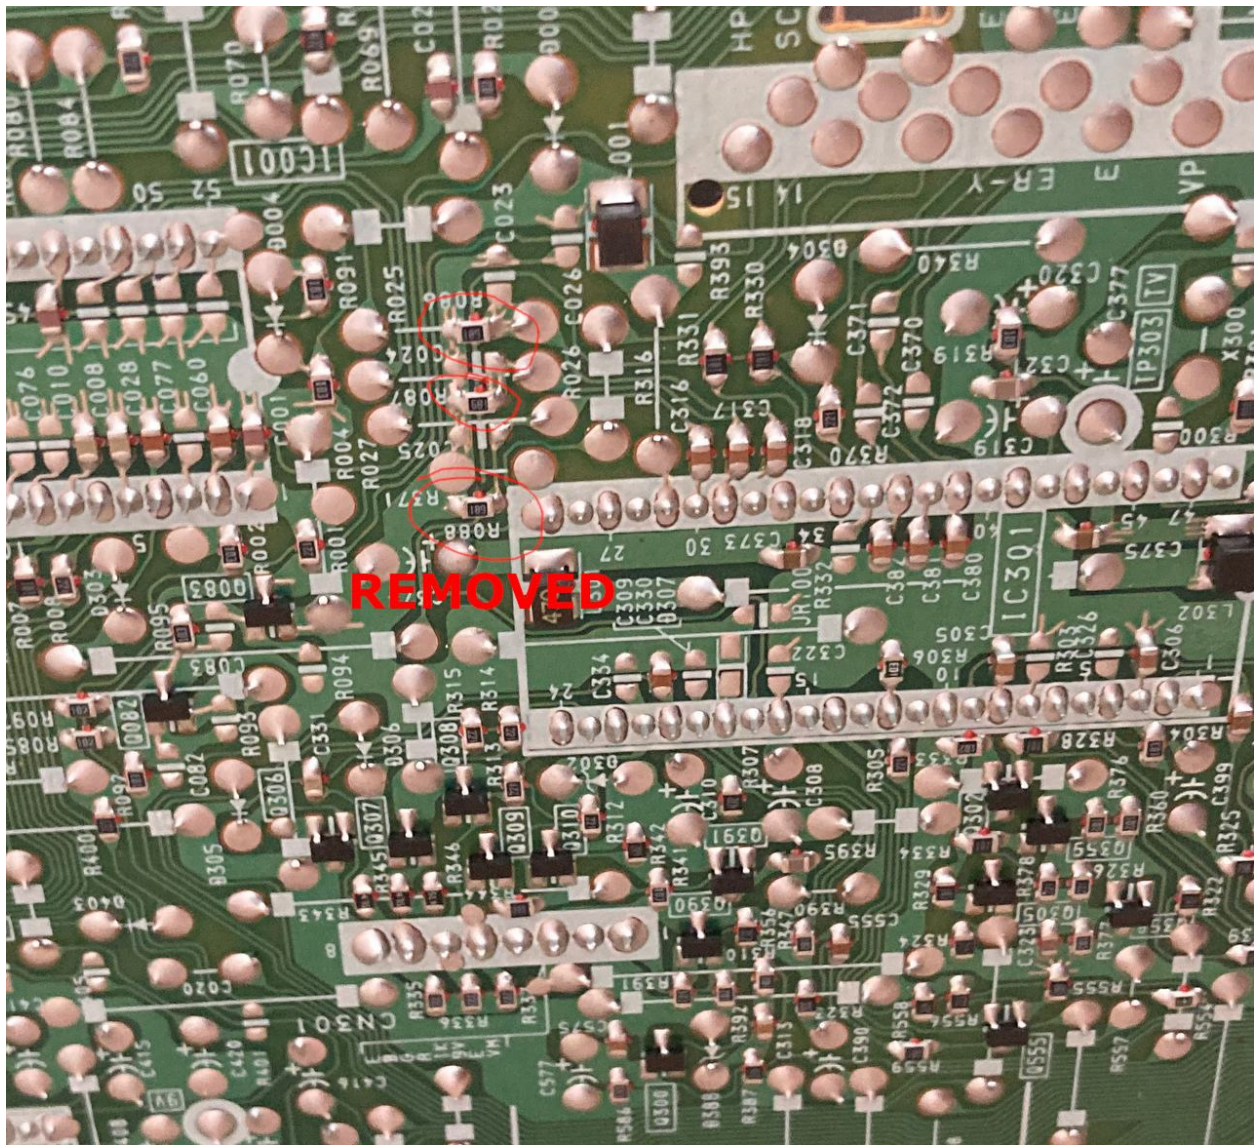
Removed R086, R086, R088

Instead of R086

Connected new 680R resistor to leg of R025 instead of removed R086.

R025 --- R086 new ----*---- 75R resistor --- GROUND

| Red signal from BNC

Same for green and blue.

Sync BNC connector is routed to composite video1 in.

Back mounted rocker switch connects "jungle" IC301 blanking pin 29 to +5V via 1K resistor.
